79 Peak Road - 山頂道79號

Ground Floor Plan (Carpark)
地下平面圖 (停車場)

First Floor Plan 一樓平面圖

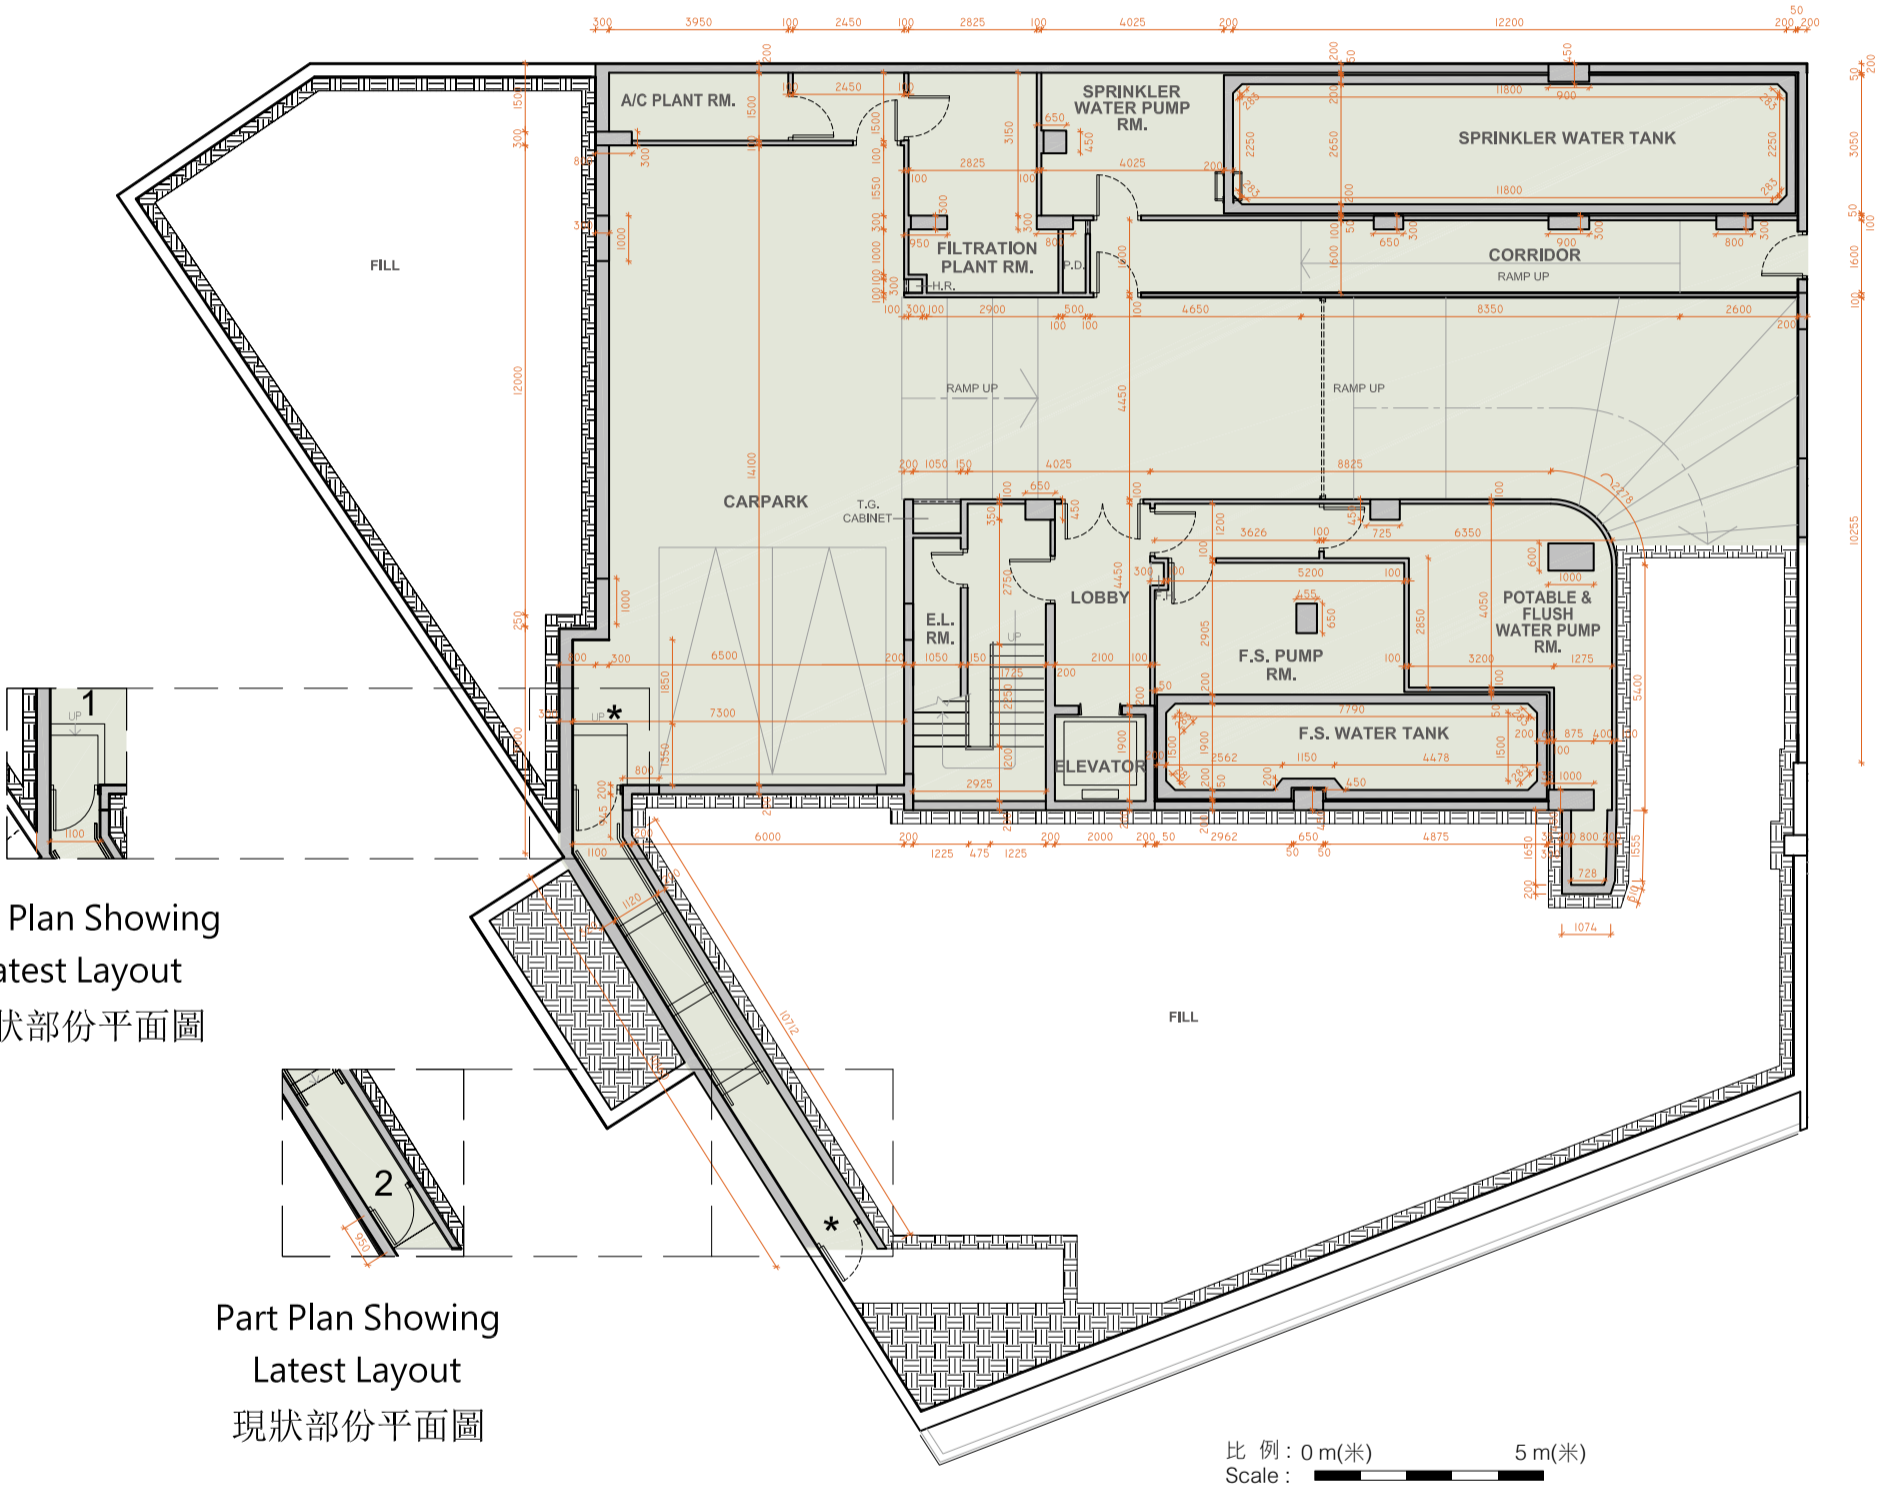
* This part of layout has been altered by way of minor works or exempted building works under the Buildings Ordinance after completion of the Development, the latest condition of which is shown on the relevant part plan.

- The alteration works are as follows:
1. Steps layout has been amended.
 2. Door at corridor has been shifted.

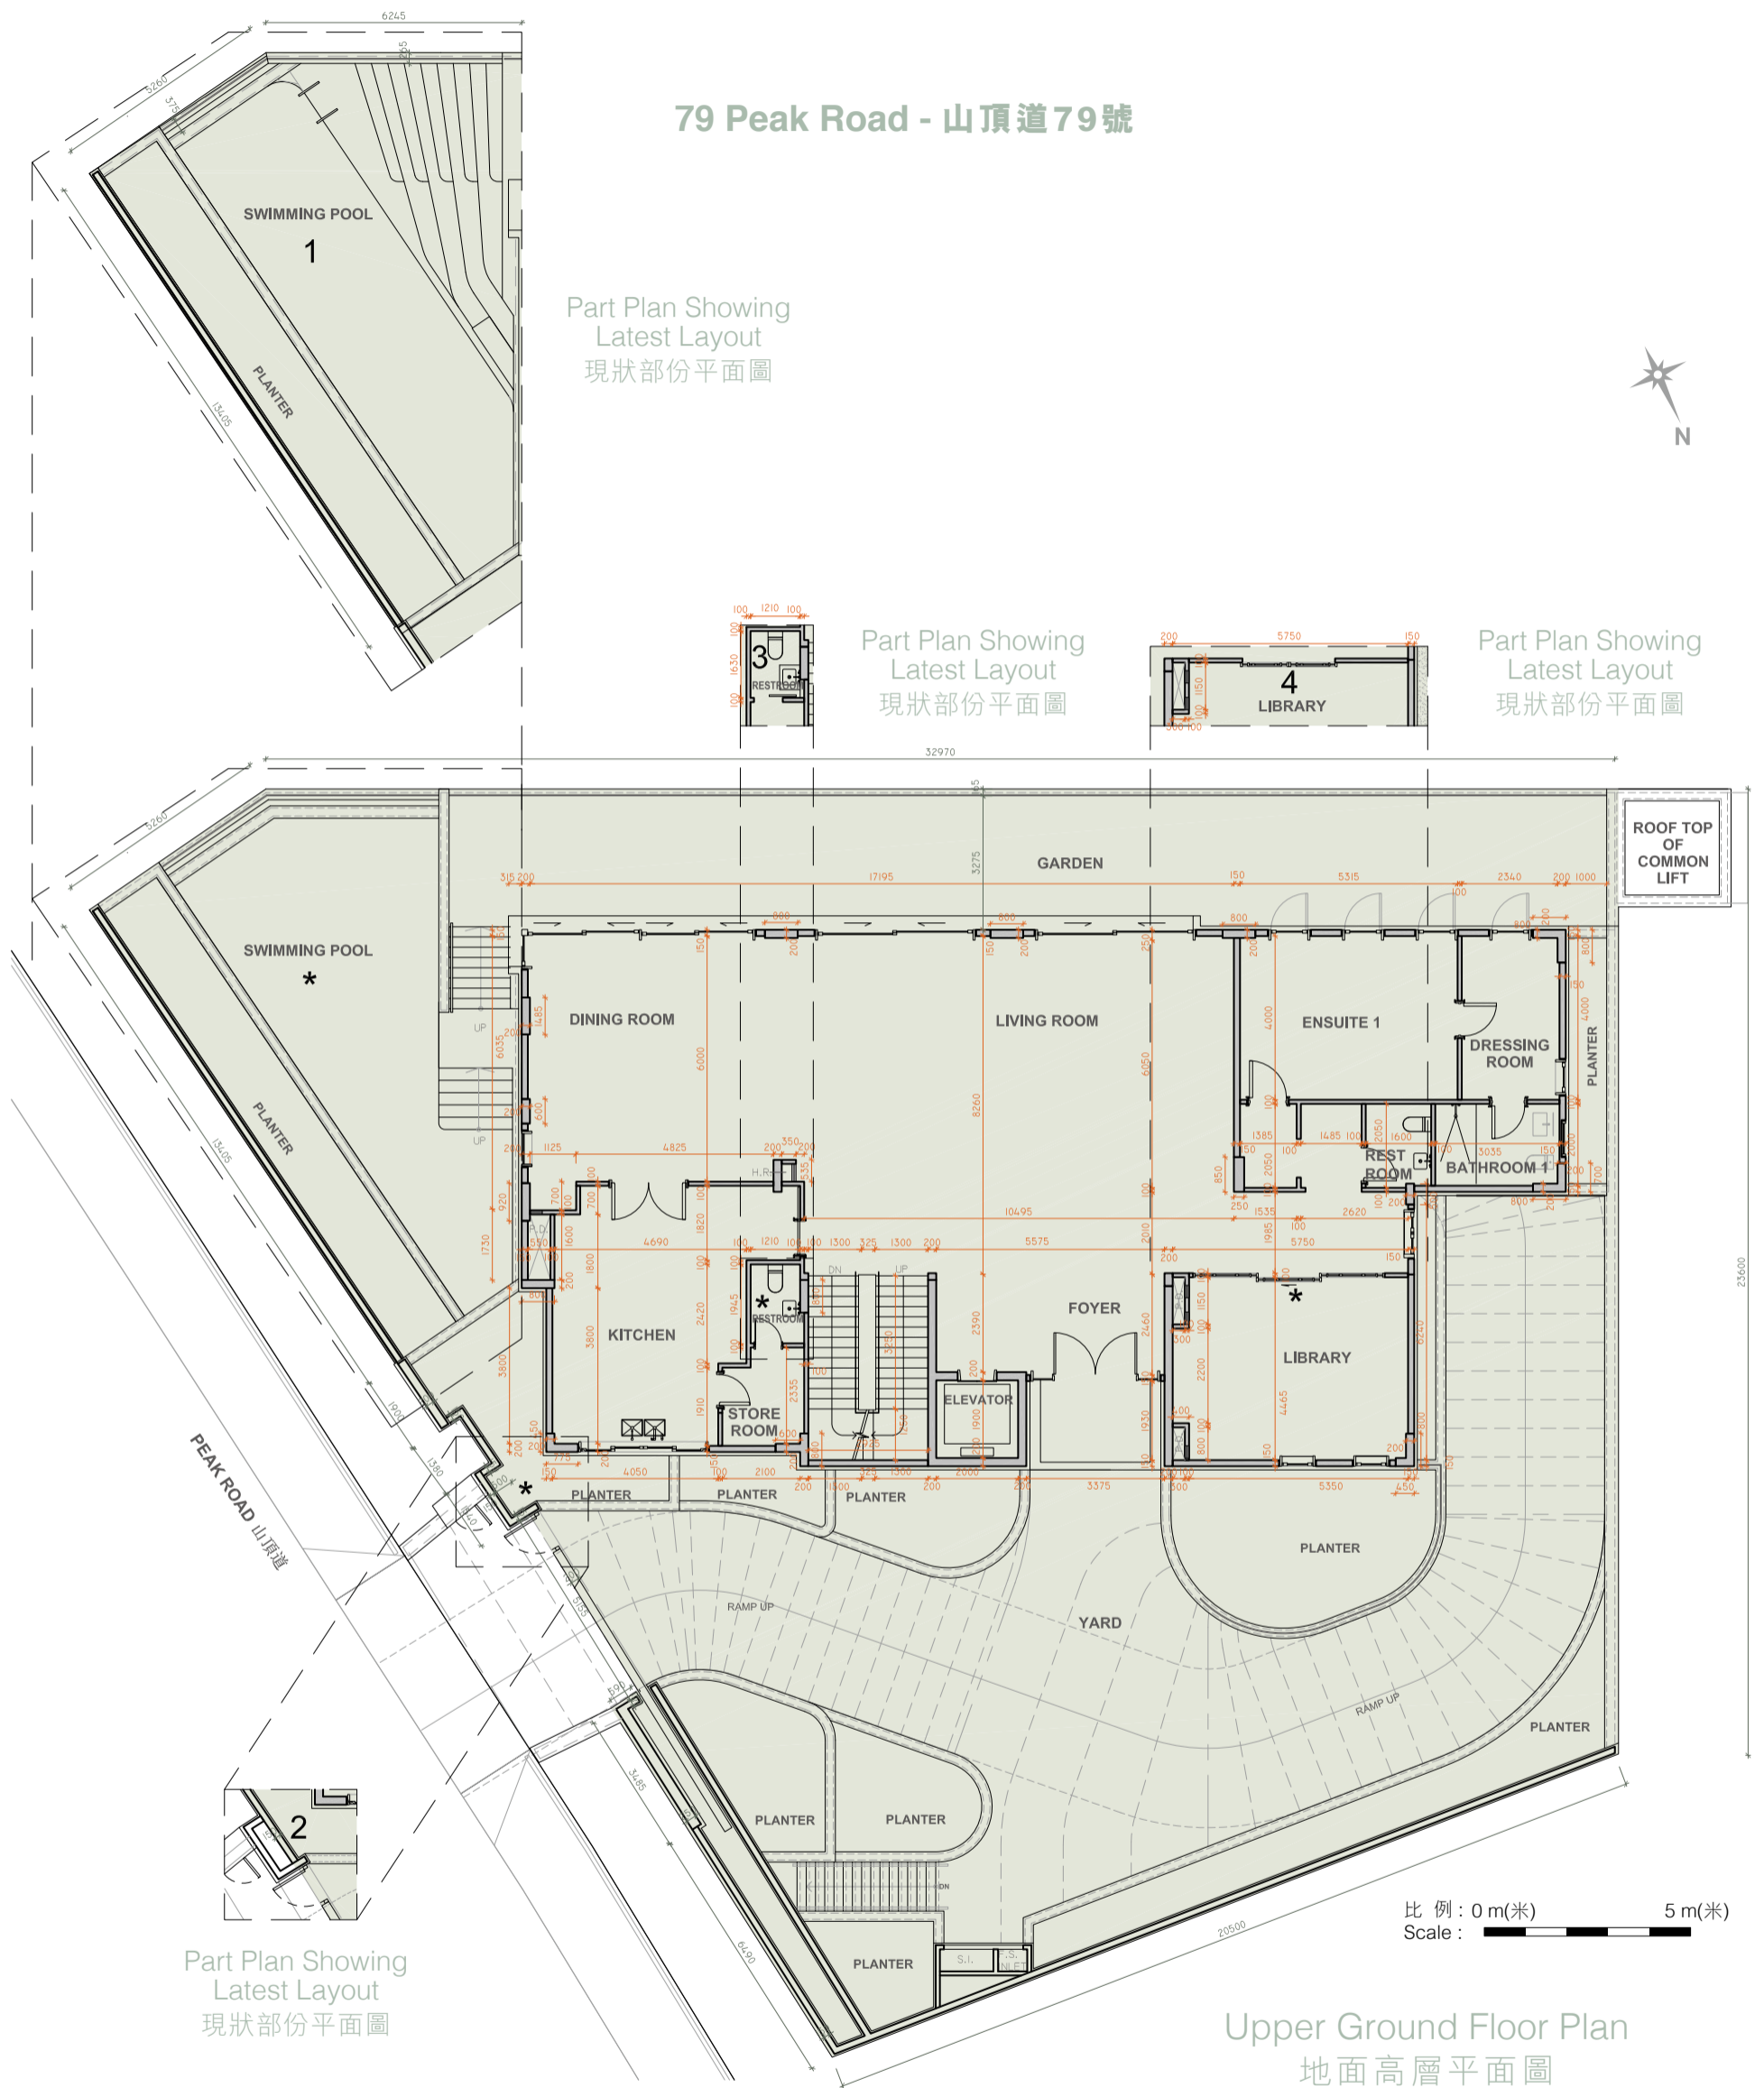
* This part of layout has been altered by way of minor works or exempted building works under the Buildings Ordinance after completion of the Development, the latest condition of which is shown on the relevant part plan.

The alteration works are as follows:

1. Swimming pool layout has been amended.
2. Fence wall layout has been amended.
3. Non-structural wall at Restroom has been shifted and the swing door changed to sliding door.
4. Single sliding door at Library changed to double sliding door.

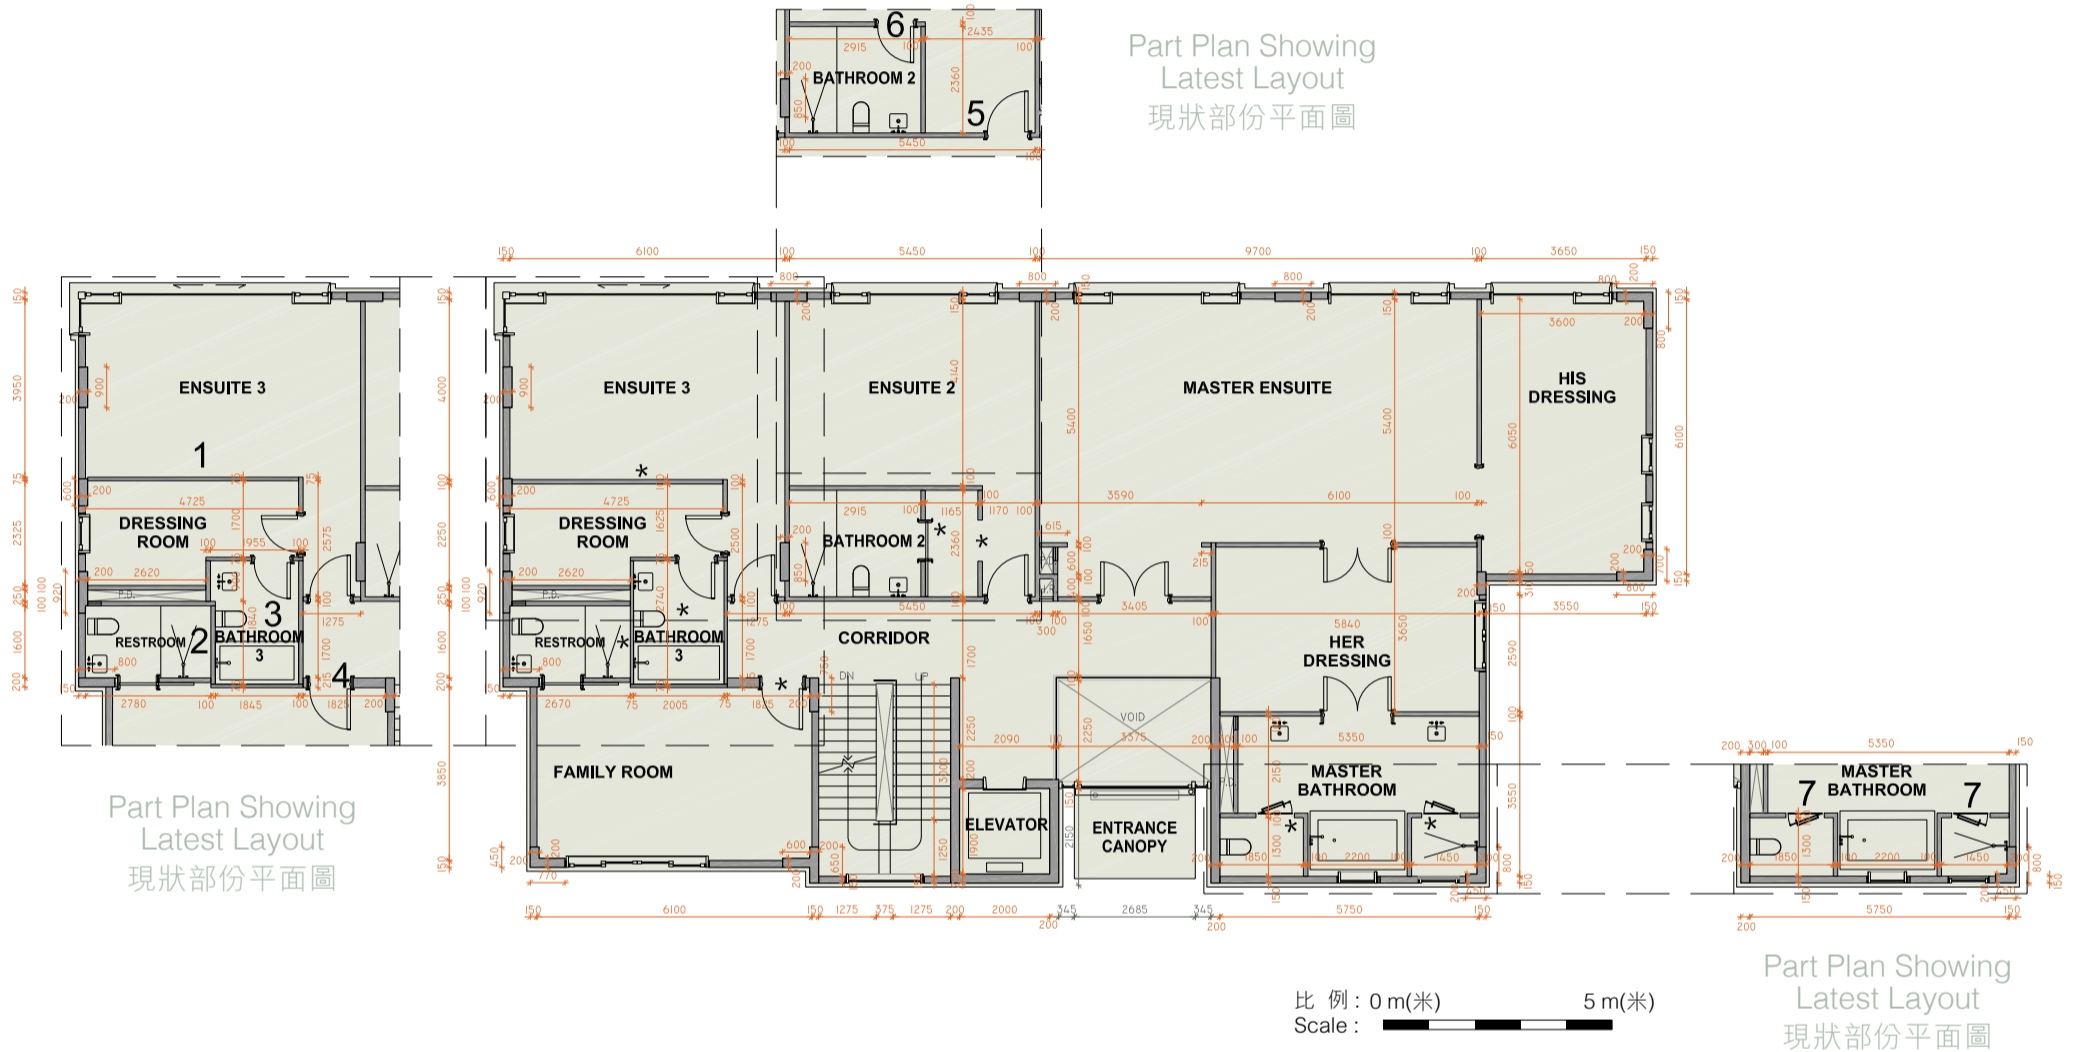
* This part of layout has been altered by way of minor works or exempted building works under the Buildings Ordinance after completion of the Development, the latest condition of which is shown on the relevant part plan.

The alteration works are as follows:

1. Non-structural wall between Ensuite 3 and Dressing Room has been shifted.
2. Non-structural wall between Restroom and Bathroom 3 has been shifted.
3. Bathroom 3 layout has been amended.
4. Door at Family Room has been shifted.
5. Non-structural wall at Bathroom 2 has been omitted.
6. Door location for Bathroom 2 has been changed.
7. Direction of glass door within Master Bathroom has been amended.
